**Report** Dr Otani  
Tower House  
125 Canterbury Road  
Westgate-on-Sea  
CT8 8NL

**Property** Tower House  
125 Canterbury Road  
Westgate-on-Sea  
CT8 8NL

**Date of Survey** 24<sup>th</sup> February 2017

**Our Ref** P36055

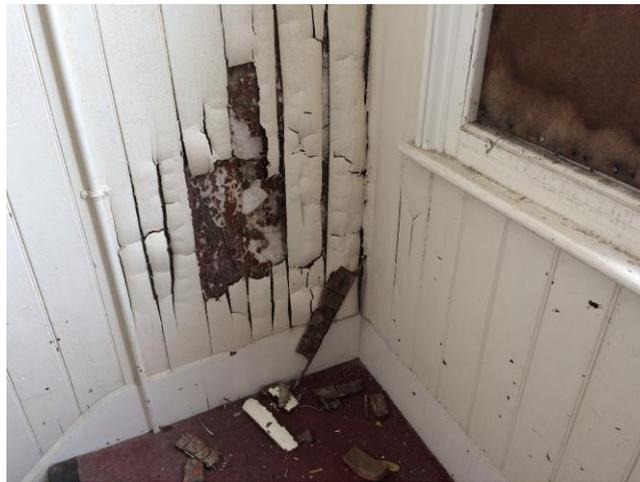
Fungal decay was noted to the timber cladding on the half landing of the left-hand staircase. It is understood that this staircase will be removed during the refurbishment and conversion.

The infection appears to be true dry rot fungus *Serpula lacrymans*. The source of moisture is most likely lateral moisture penetration from an external defect. Inspection is based on a close but not intimate examination of the areas specified. Inevitably there will be timbers which could not be inspected fully, or at all, without opening up the areas. We have, so far as possible, inspected the accessible exposed surfaces available to us. Our recommendations are true therefore subject to the qualification that further necessary work may be required once the fabric of the building or a particular element is exposed. This applies particularly to the true dry rot fungus *Serpula lacrymans*. Should you require a full exploratory examination works or disruptive exposure, we would be pleased to quote for these works. However, should you proceed on the present basis, we shall advise you of any further investigations or fungal infection that we discover during execution of the works and advise accordingly, with a supplementary report and quotation. Dry rot can in certain circumstances cause serious damage by its rapid growth and we would recommend that treatment is carried out as soon as possible.

1. Hack off the wall plaster to the heights and dimensions indicated on the attached sketch plan and bag up the resultant debris for disposal
2. Technicians are to carry out drilling, irrigation and sterilisation of the exposed masonry using the appropriate fungicide solution
3. This treatment is to be complemented with a surface application of the chemical
4. Carry out full chemical treatment accessible timbers against wood boring insects, using the appropriate chemical solution to the manufacturer's instructions
5. No allowance has been made for re-plastering in this instance

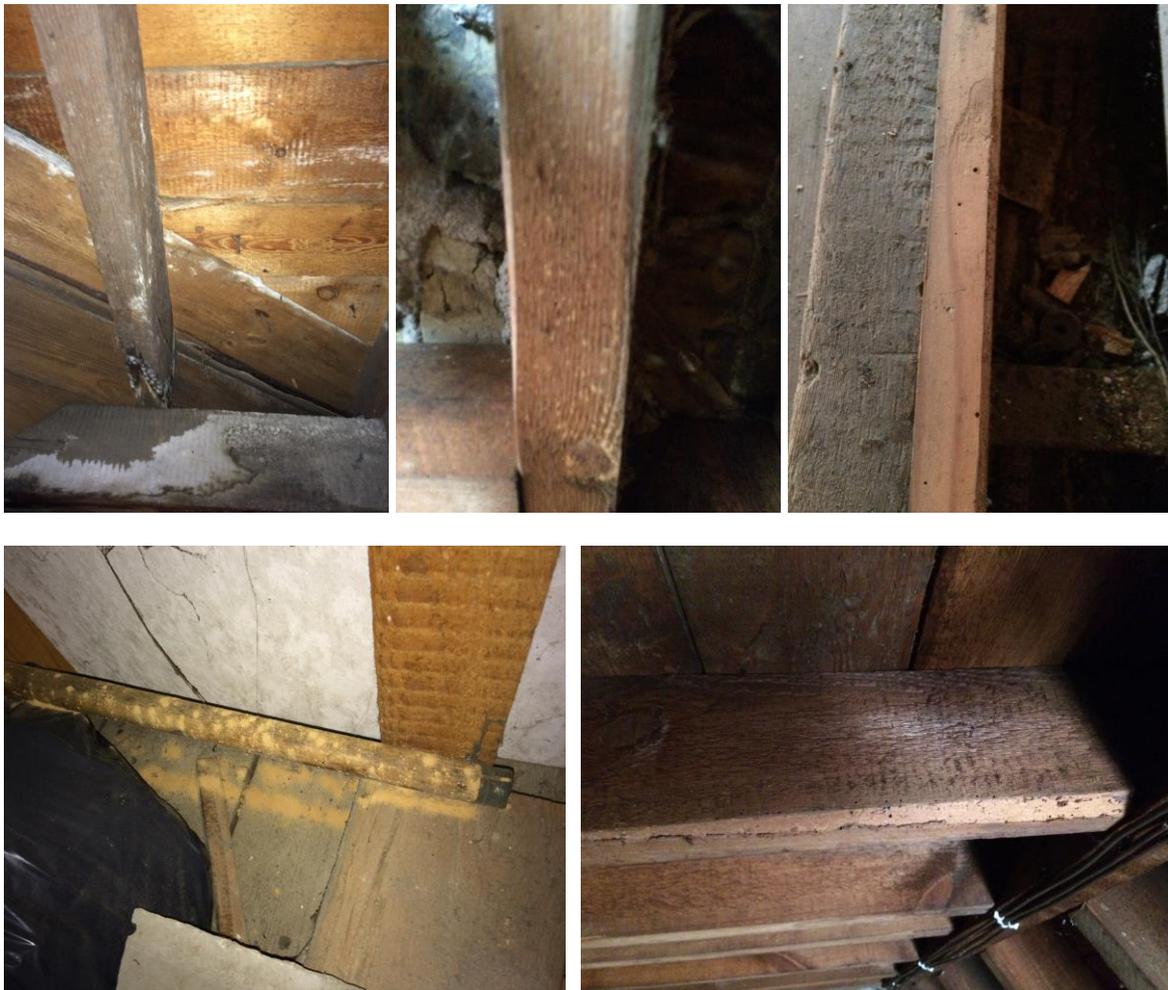
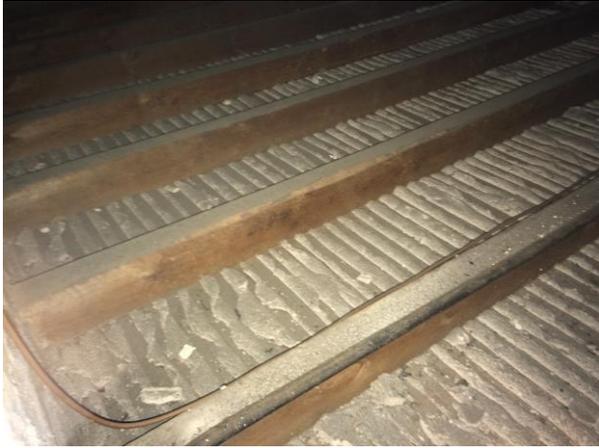
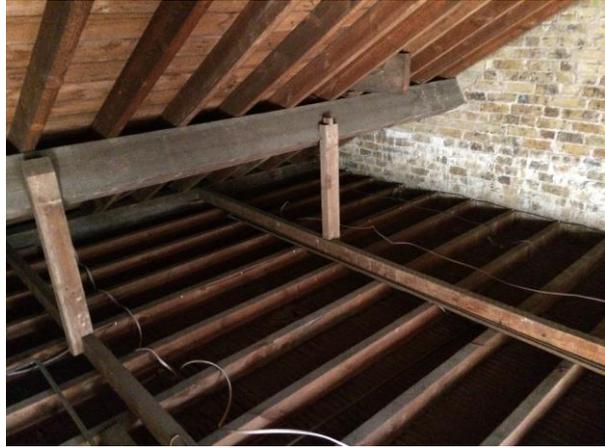
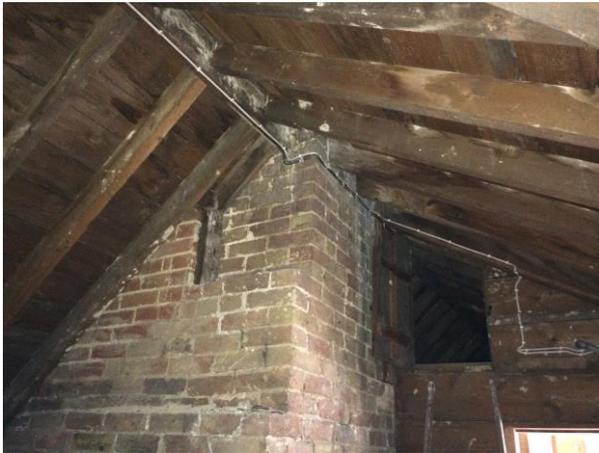
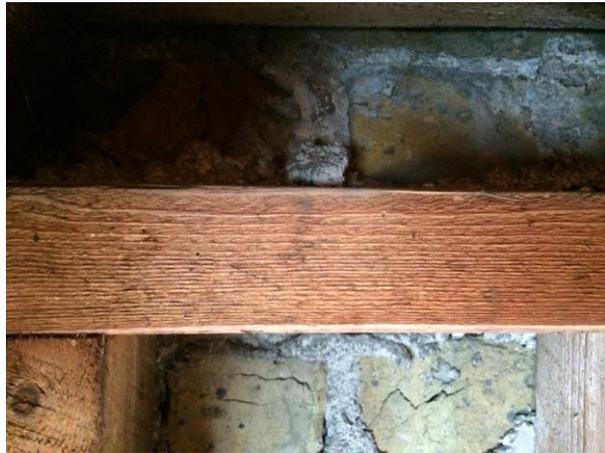
Inspection to some areas was restricted by plasterboard secured to the rafters and ceiling joists. Where inspection was possible, there was evidence of wood borer activity with bore holes of recent origin denoting larval activity.

The infestations appear to be scattered and isolated across all the roof voids inspected. There were also several areas of staining from historic roof leaks. Some timbers were tested with higher than normal moisture meter content recorded.

Dual purpose treatment will be required to the inspected areas. An allowance has been made for the treatment to maximise fluid penetration of the accessible timbers, as indicated on the enclosed drawing. An additional sum has been included for the clients' information, to treat the entire roof void which is recommended.
