Your Ref :
Our Ref : TS529

24 February 2016

125 Canterbury Road, Westgate-on-Sea, Kent Feasibility of Proposed Structural Alterations

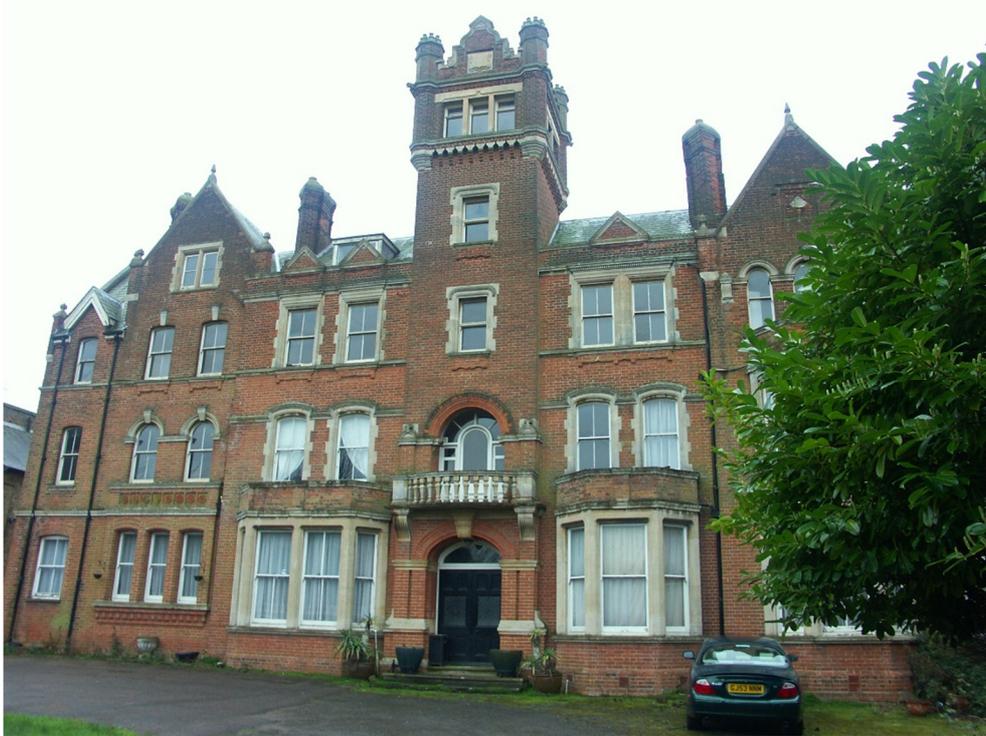
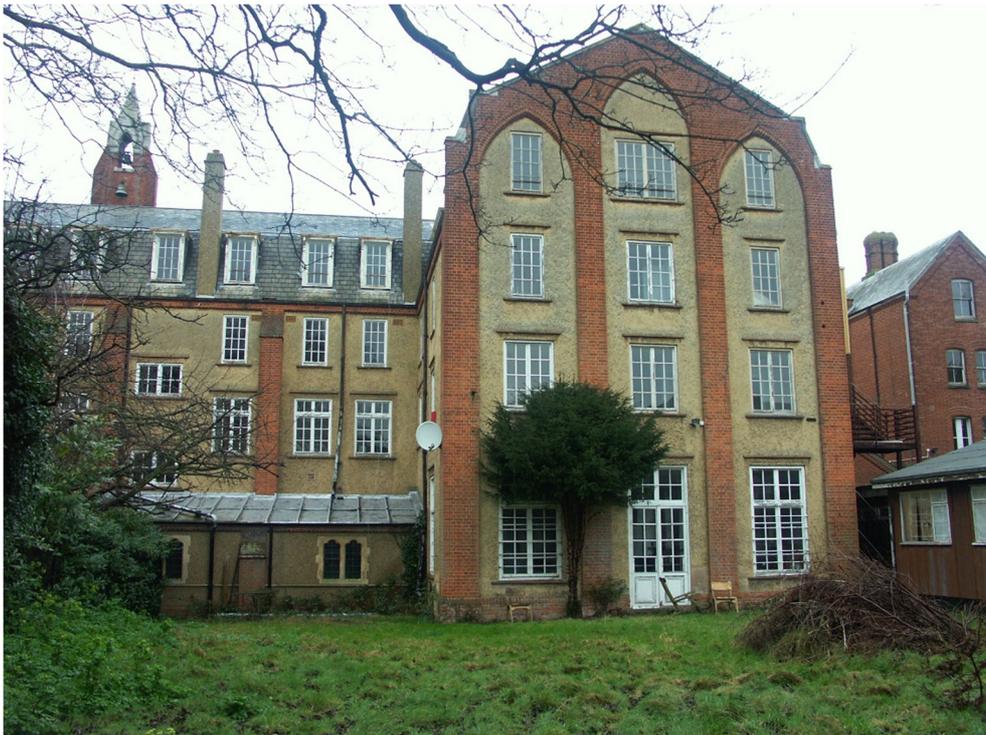
The main part of the building has up to five storeys with a basement under part. It is attached to the adjacent property, which is a similar sized building, and to a single storey outbuilding at the rear. The main part of the building appeared to be of conventional construction with timber roofs, timber first, second and third floors, concrete ground floors except over the basement which were timber, and solid masonry external walls. The outbuilding is of timber-framed construction, including timber roof trusses, and has concrete ground floors. The photographs below show the front and rear elevations of the main building.

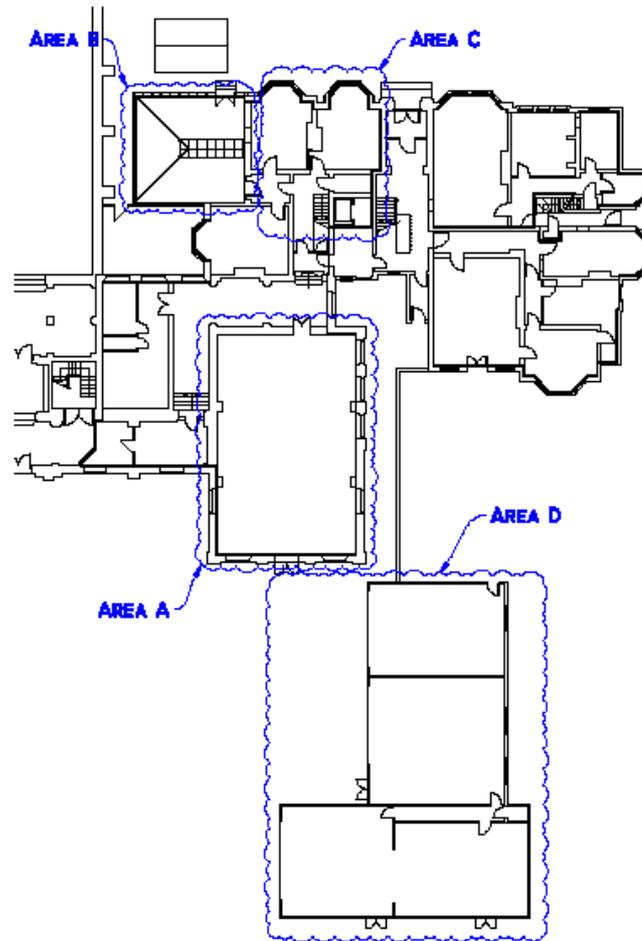
Four specific areas were inspected. These have been called Areas A to D for reference purposes only and are located where shown on the plans below. No parts of the building outside these areas were inspected.

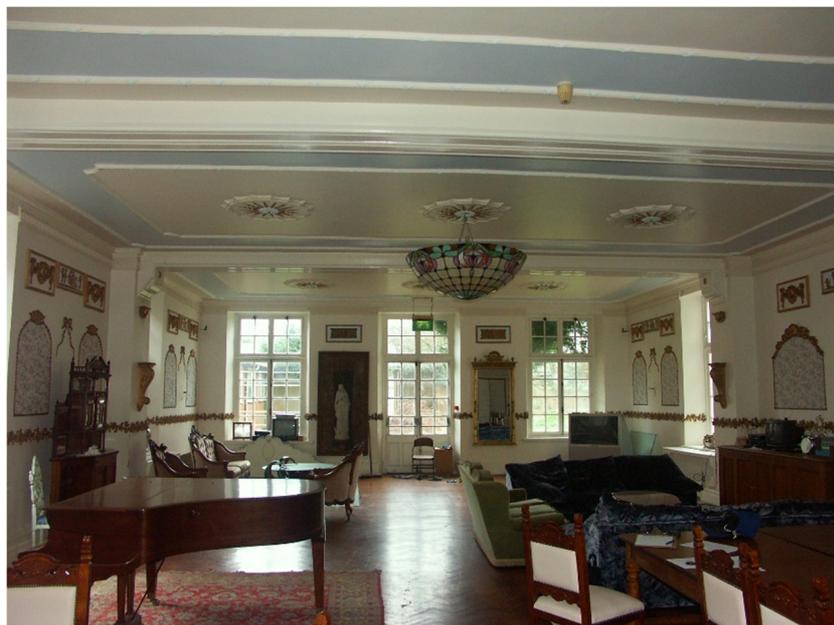
At ground floor level there is a single room approximately 14m x 9m in plan (photograph below).

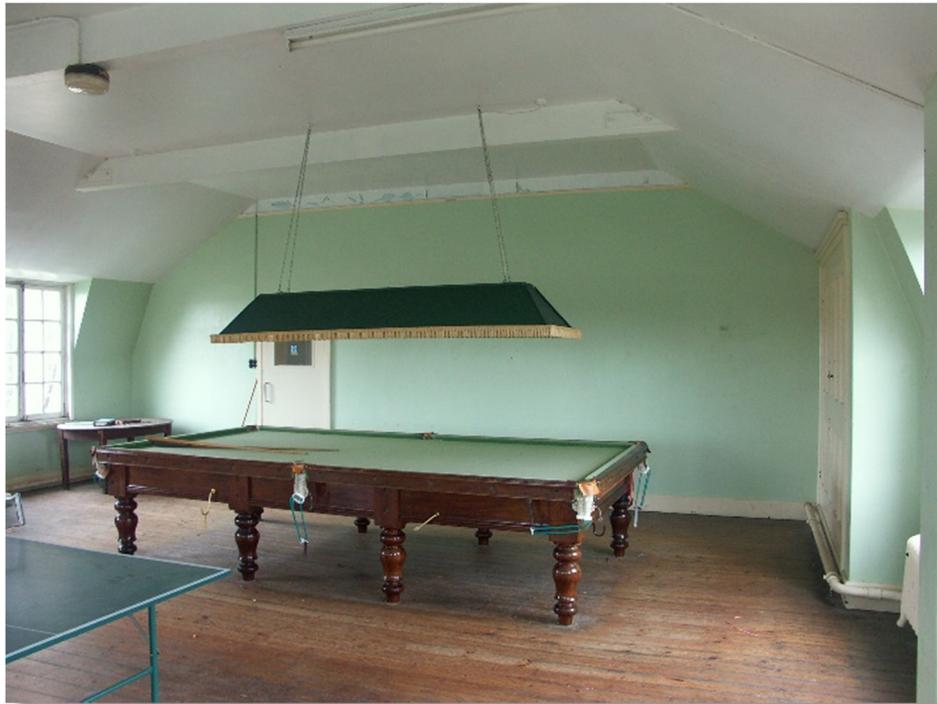
The first and second floors are divided into rooms off a central corridor. The third floor is open over two-thirds of the area (photograph below) with a stairwell in one corner and another stairwell and other rooms in the remainder, sub-divided by partitions which appear to be non-loadbearing timber.

As far as can be seen from limited opening-up, it would appear that the roof, which is part vaulted and part flat, spans between the external side walls. The first, second and third floors are all timber and appear to span between the walls at each end of this area and internal loadbearing walls which are directly above the two downstand beams which can be seen in the ground floor ceiling. All other walls at first, second and third floor levels appear to be non-loadbearing and of timber stud construction. The two downstand beams appear to be supported on substantial masonry piers within the masonry external side walls.

Our understanding of the proposal is that the rooms at first and second floor will be partly reconfigured. This mainly involves changes to non-loadbearing and lightweight stud partitions but also the formation of four new openings in the internal loadbearing masonry walls, one at first floor level and three at second floor level. At third floor level only the addition of one non-loadbearing lightweight stud partition is envisaged. We would need to see detailed proposals and assess the proposed changes in detail to satisfy Building Control requirements, but our view at this stage is that the proposed changes would not significantly alter the way in which the structure works. In general the loads on existing structural elements will remain the same or may decrease slightly. There are a few areas where a slight increase in loading may occur, but it should be possible to provide measures to address the increase or determine that it is not significant. It will not be possible to justify the existing beams, piers, foundations etc. by calculation without very extensive opening-up, but we consider it reasonable to assume that the structure can be considered as adequate provided that the loading is not increased, or if it is increased slightly in parts by only a small amount.

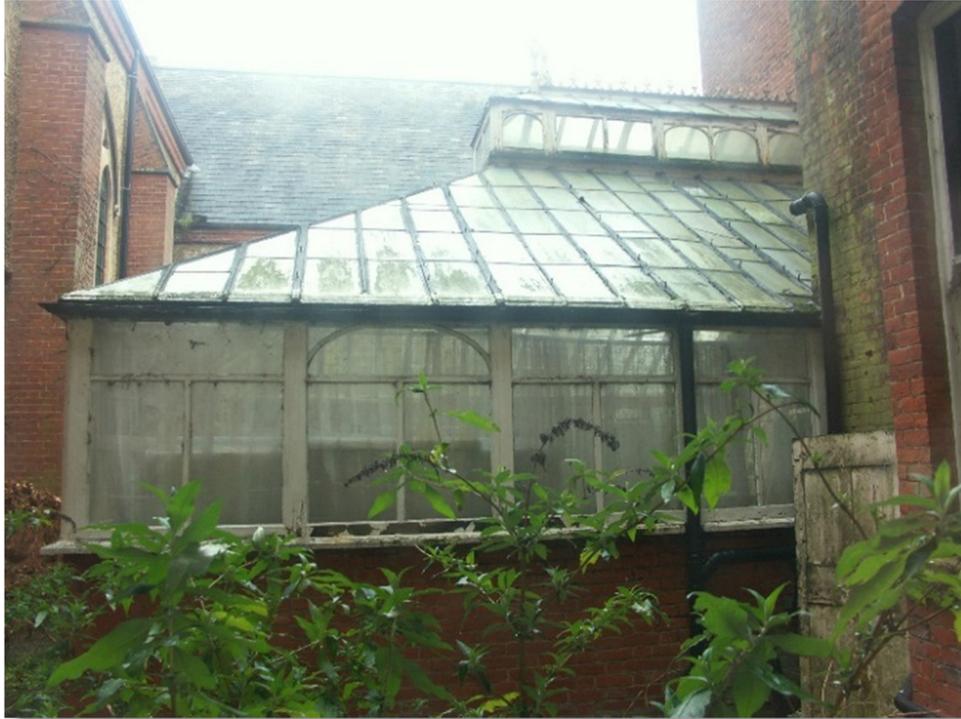
This area is a single storey timber-framed conservatory structure, attached to the main building, as shown in the photographs below:

The structure appears to be stable and undistorted but is in poor condition with much rot, damp and deterioration evident, seemingly mainly related to water ingress.

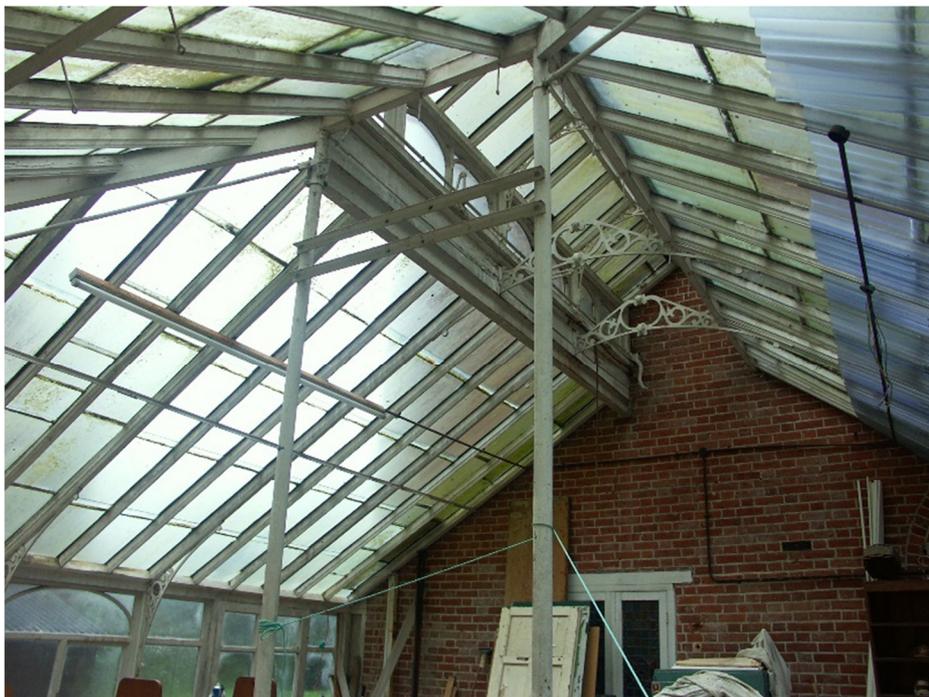
It appears that some remedial work has been carried out in the past, notably the introduction of a steel beam under one of the two timber beams along the sides of the lantern light. The horizontal steel angles between the two slender steel posts may also have been added post-construction, possibly due to concerns about the slenderness of these posts which are about 3.9m high and only about 60mm in diameter.

Our view is that the existing structure would be unlikely to satisfy Part A (Structure) of the current Building Regulations, not least because of the slender posts and overall stability issues. However the conservatory has clearly stood for many years with no major signs of structural distress apart from the apparent addition of a remedial steel beam. If the decay and deterioration can be addressed we see no reason why the structure should not be retained, although we would suggest the addition of another steel beam to the lantern to match the one already installed. We assume that the existing single glazing will not be replaced with double or other heavier glazing as this would clearly be a significant additional load that the structure would be unlikely to be able to support.

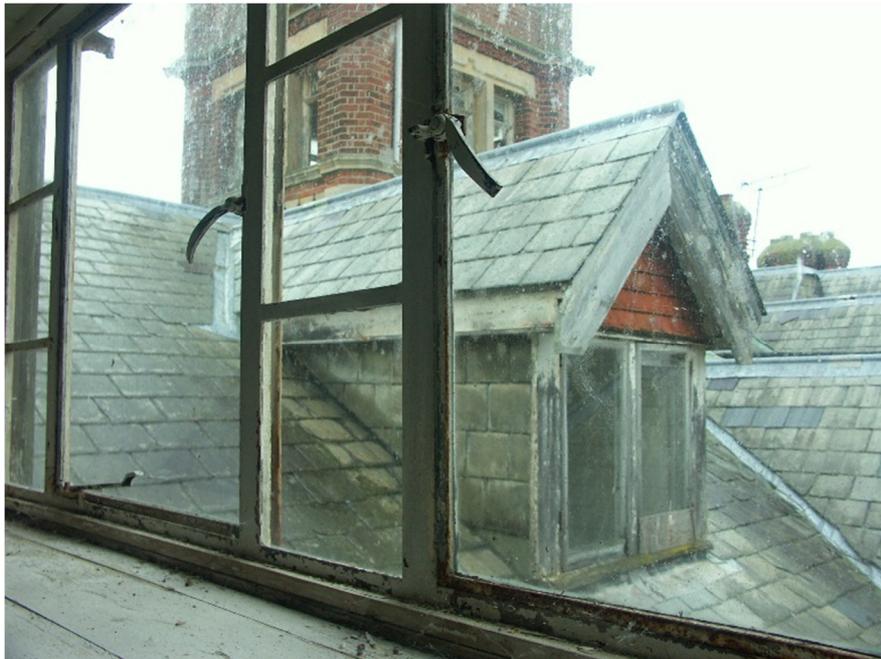
We understand that the lift being considered will be supported at its base, probably on a reinforced concrete slab or lift pit. All vertical load will therefore be transferred down to foundation level and should not need to be supported on the existing structure. A substantial masonry wall exists at all levels adjacent to the lift location which will probably be suitable for fixing guide rails etc. to and for lateral stability of the lift. This wall, and a corresponding one on the other side of the rooms into which the lift will be introduced, can be used to support the floors and their trimming around the lift well and openings. Alterations will be required to the roof structure at the top of the lift as its position conflicts with the existing dormer window shown in the photograph below.

Opening-up and survey work is required to establish how the existing roof structure is arranged in this area, so as to enable the design of a suitable trimming or other support arrangement.

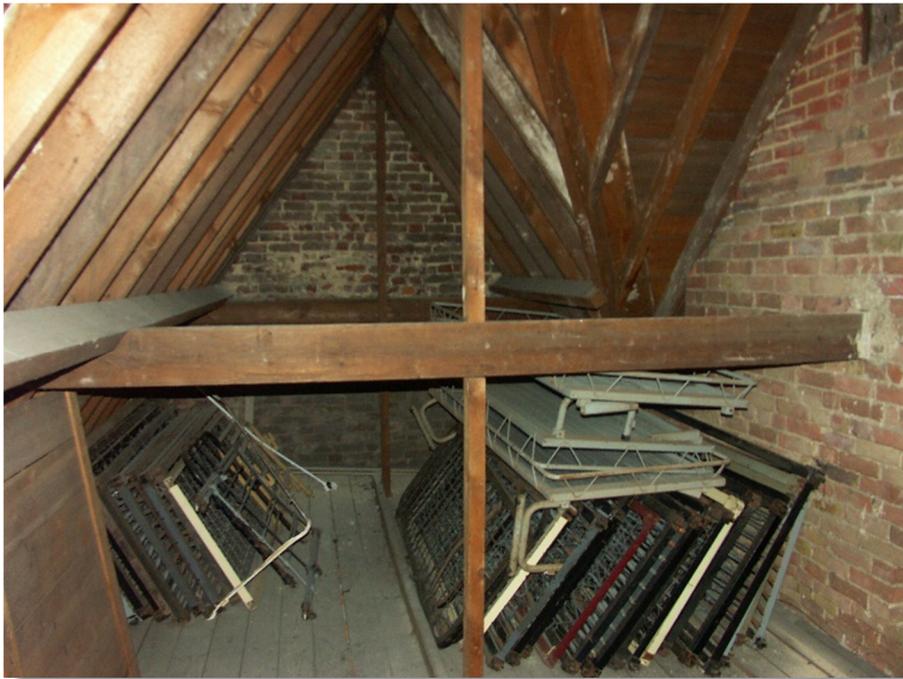
The nearby roof void and roof structure is shown in the photograph below:

In its current configuration this area is unsuitable for use as a habitable room due to the large number of purlins, struts, ties and binders which intrude into the space. The rafters, and probably also the ceiling joists, will need to be replaced or strengthened with additional timbers to suit insulation and other details and to strengthen them for the additional loads and altered configuration. We envisage a series of ridge and valley beams supported off the gable walls and the chimney which would allow all the internal timbers to be removed.

We therefore conclude that this area is structurally suitable for the alterations proposed, subject to further survey and detailed design.

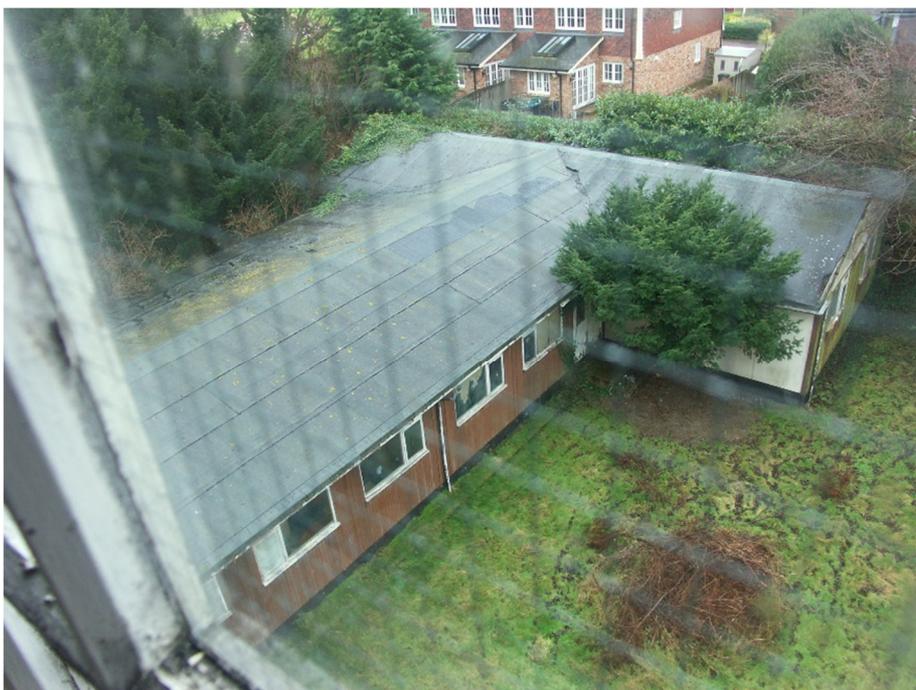
This area comprises a pitched roof single storey 'T' shaped outbuilding, currently linked to the main house by a further single story building which is to be demolished, as shown in the photograph below.

The structure comprises a felted roof supported by fibre board sarking spanning between proprietary low pitch timber trusses. The trusses are supported off external and internal timber stud walls. The ground floors are tiled and assumed to be ground-bearing concrete slabs.

We understand that the intention is to form openings in the external for folding doors which will be up to 4.8m wide. This can be achieved with steel 'goal post' frames (beams with supporting posts at each end) to support the roof and folding doors, as well as providing additional lateral stability. Pad foundations under each post may be required, depending on the details of the existing foundations and ground conditions.

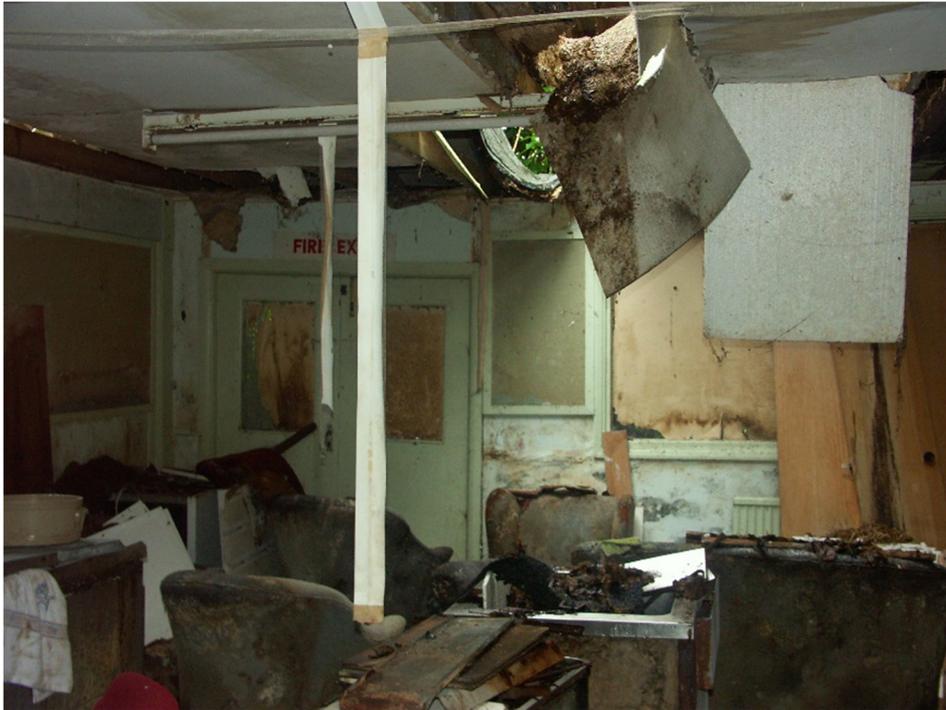
The general condition of the structure is poor and water ingress was seen in several places. Parts of the roof and ceiling have collapsed, as shown in the photograph below.

We believe that the existing structure can be retained, provided that all elements damaged directly or indirectly by water ingress are repaired or replaced, and that any replacement roof covering does not exceed the weight of the materials currently being supported. The truss nail plate connections also need to be inspected to ensure that they have not corroded.
